Failure Analysis of a GRP Tank

Design and Structural Analysis

Case Study

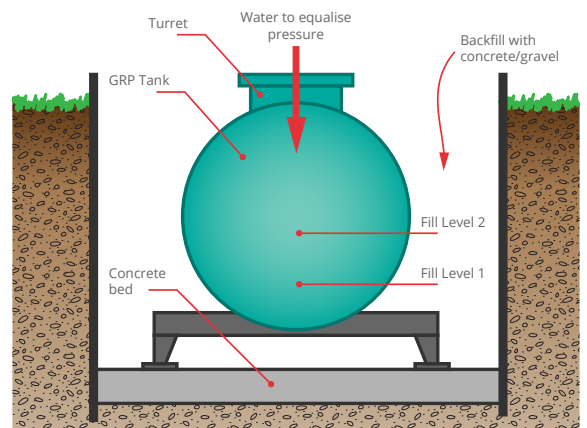
Schematic of tank in excavated chamber prior to backfilling

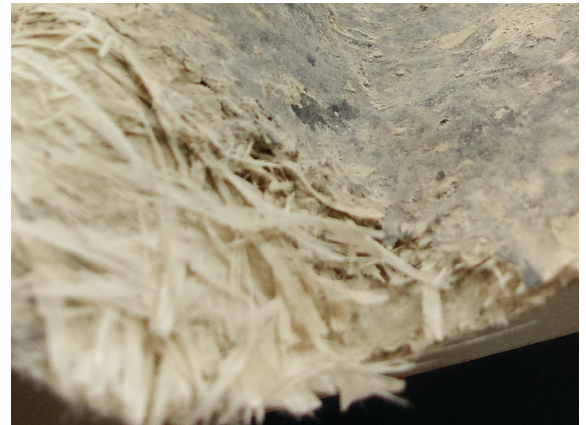
From physical-characterisation tests it was determined that the thickness of the GRP ranged from approximately 2.00 mm to 3.50 mm; in regions close to the rupture, the GRP thickness measured as little as 2.01 mm. Some specimens exhibited significant delamination between sprayed-up layers, and the thin areas around the rupture appeared to be very dry (i.e. there is too little resin to bond, and allow stress to be transferred, to the fibres). Composite-density measurements also showed that voids accounted for a significant part of the material's volume.

It is not unusual for the region around a rupture of this nature to appear to be resin-poor. However, when volume and density calculations were carried out on a small piece of GRP cut from the samples, it could be seen from the sectioned specimens that other areas of the GRP showed delamination between the sprayed-up layers.

The density of the GRP was found to be $\sim 1350 \text{ kg/m}^3$, which suggests a fibre volume fraction of only 10%. A similar calculation carried out on a disc cut from the turret yielded a composite density of 1410 kg/m^3 , consistent with a fibre volume fraction of around 16%. A typical value for the volume fraction of fibres in a sprayed-up GRP composite is 25%. A result of 10% in a composite that looks so dry suggests there is a significant quantity of air (debonding and voids) within the composite material. It should be noted that there was also evidence of delamination in the disc cut from the turret.

Visual inspection of sample showing debonding and voids

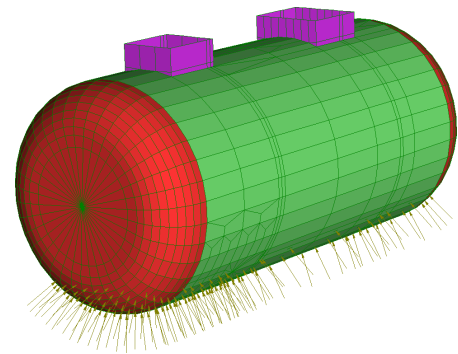
Different load cases (representing the conditions experienced by the tank during installation) were created for two laminate thicknesses at two depths of concrete. The tank ruptured during the second or third pour of concrete; the client estimated that the depth of concrete at this stage was between 400 mm and 900 mm. Load cases were applied using the 'effective pressure' of the concrete at pour-depths of 400 mm and 900 mm. For the FEA simulation, the wall of the tank cylinder is taken to be 2 mm at its thinnest and 3.5 mm at its thickest.

The FE model was fixed (no translation or rotation permitted) at the legs; the GRP was assumed to be isotropic, and any rupture was assumed to begin at the onset of material failure.

Model showing tank geometry and applied load

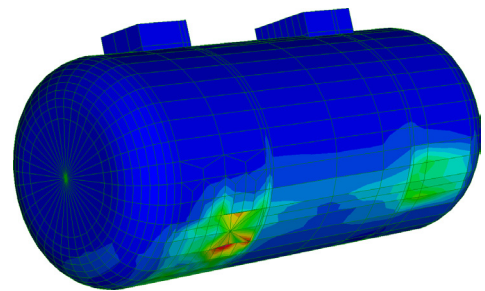
The simulations showed that the lowest value of stress the tank would have to withstand in these regions was nearer to 91 MPa, and that the highest was over 340 MPa - both far beyond the estimated strength of the material. To withstand such conditions, the tank would have to have been 7 mm thick. Simulations using strength values for a typical 25% fibre-volume fraction showed that a 4 mm thickness of GRP would have met such conditions.

Given the information supplied, i.e. the photographs, the drawings, and the physical samples, Coventive concluded that the GRP was of poor quality, and, therefore, that the tank was below the acceptable standard of fabrication and inadequate for the design requirements.

Results showing peak stress of 340 MPa
